**FINAL REPORT ON THE ACCIDENT OCCURRED
ON 25 MAY 2008
AT BRUSSELS AIRPORT ON A BOEING
B747-209F REGISTERED N704CK**

**Ref. AAIU-2008-13
Issue date: 10 July 2009
Status: Final**

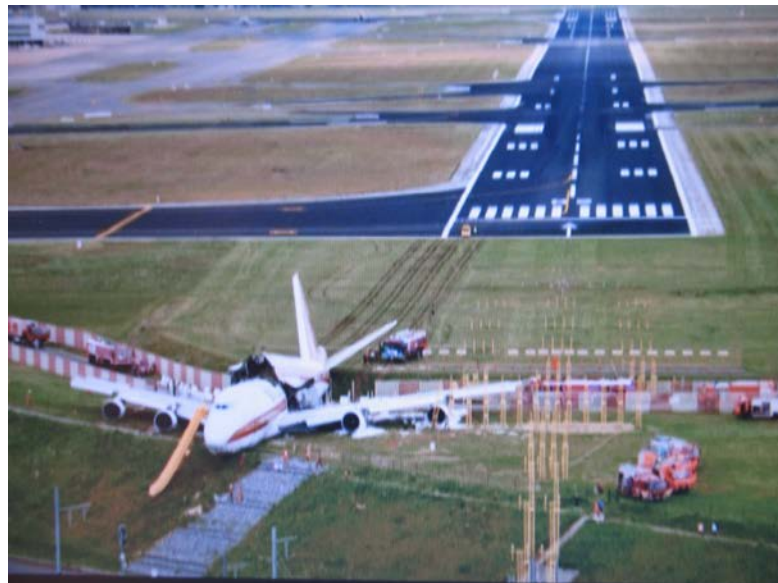
The aircraft reached a first embankment, dropping from a height of 4 m, and broke in three parts. The aircraft came to a stop just above the top of the railroad embankment.

The crew exited the airplane through the service door since the L1 door normally used was blocked due to deformation of the structure.

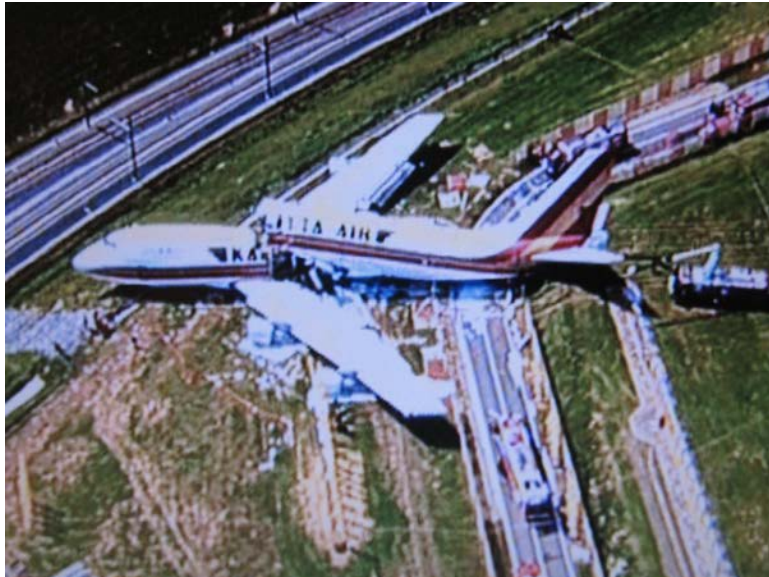
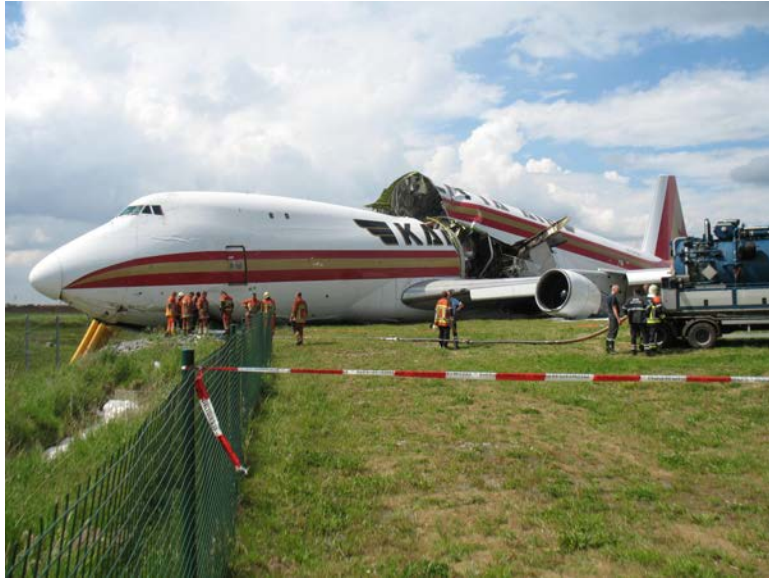
The entire fuselage was right side up at the accident site with severe impact damage and multiple skin, stringer and frame fractures. The fuselage fractured into three sections. The first major fracture of the fuselage – on the RH side – was located at about FS 1100 and the second at FS 2285.

The second section of fuselage, the fuselage skin, stringer, frame pressure deck and overwing longeron structure are raised up approximately 1.5 meter above the wing upper skin panel.

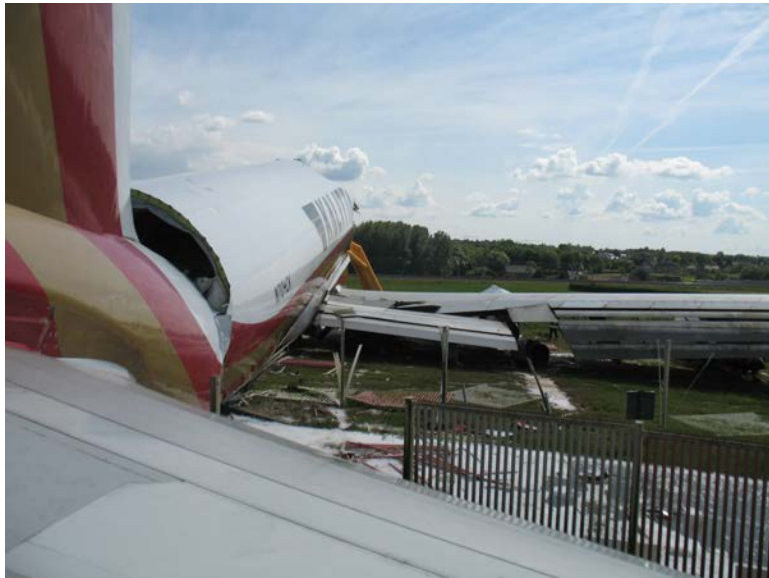
The main keel beam box was fractured just forward of the body landing gear drag brace support fitting. At the fracture, the aft keel beam is lifted up and separated from the forward keel beam.

The aft fuselage fracture was located at the tail section, just in front of the rudder.

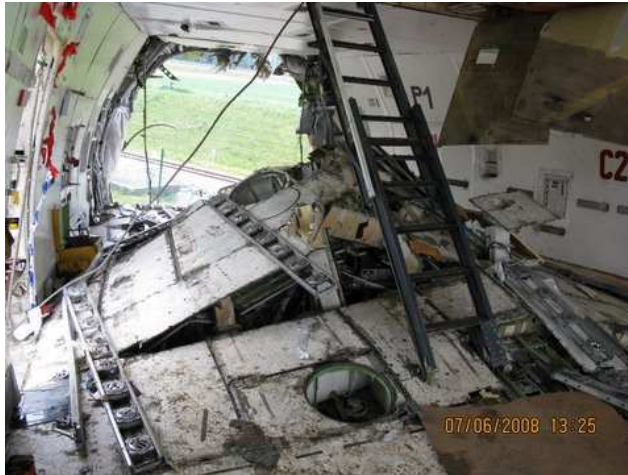
The main cargo deck portion located in the forward section of the fuselage was fractured and pushed up in the area where the nose gear penetrated the lower lobe of the fuselage.

The most forward cargo pallets (P1 and P2) were no longer secured by the cargo locks.

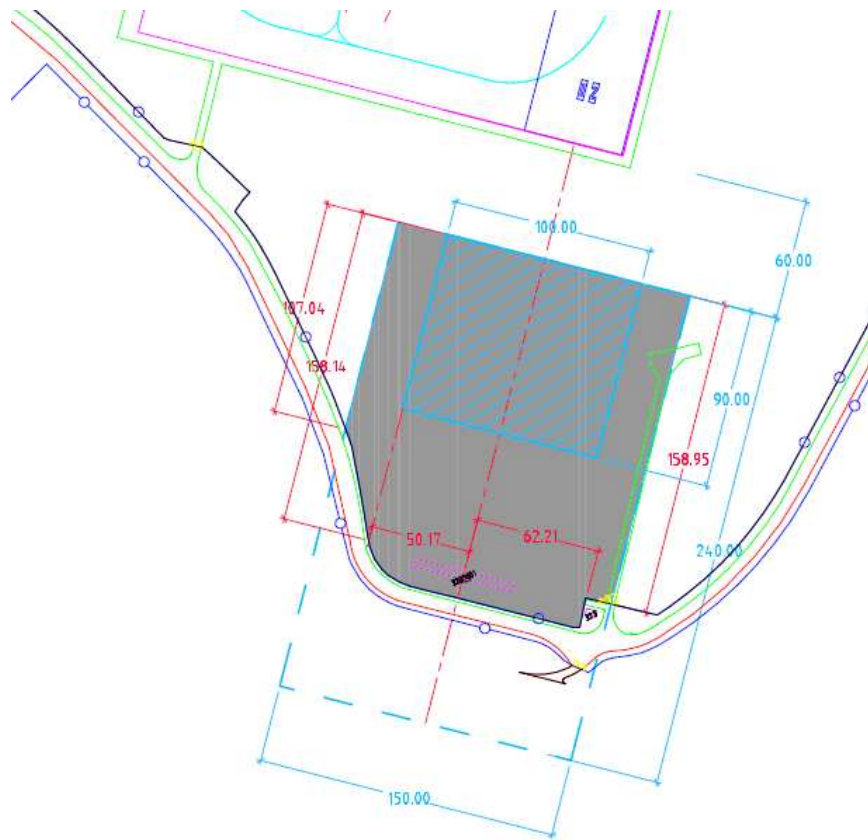
The RESA of runway 20 complies with the requirements of ICAO Annex 14 (min length of 90m, min width of 90m).

However, the same ICAO Annex 14 recommends to extend the length of the RESA to a distance of at least 240m. This recommendation (not mandatory) is not met for runway 20.

We recommend to extend the RESA of Runway 20 of EBBR to the length recommended by ICAO, either thru physical extension, or by the use of the EMAS system discussed in chapter 1.10, or by any other suitable means, and evaluate the need to apply this recommendation to other runways and Belgian airports.

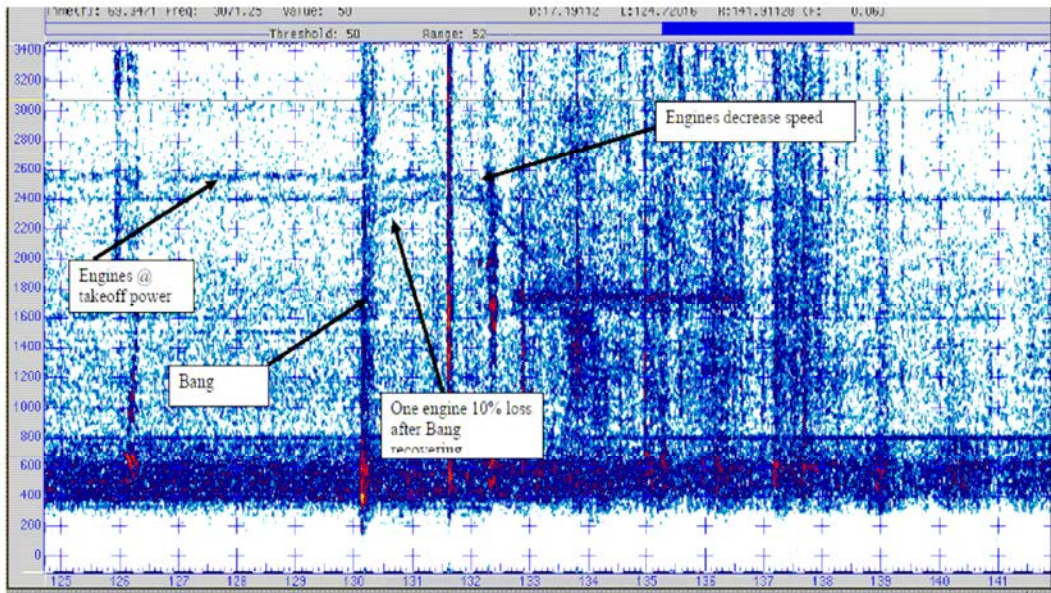
The analysis shows engine operating at take off power, then one (or more) is experiencing a loss of power, followed by a saturation (bang). The sound frequency is then moving to its original value, showing that the involved engine(s) is recovering, until the moment the power is reduced, by the pilot.

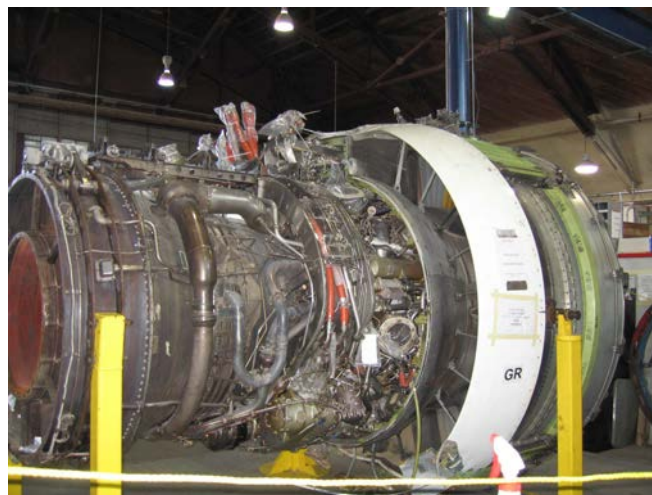
No impact marks or inward deformation of the front or rear spinners were noted. Fan blades Nos. 11, 35, 38 and 42 (86°, 273°, 297° and 328° respectively from index mark) exhibited soft body deformation with the leading edge pushed from the concave towards the convex side. The soft body damage was centered about 3-inches outboard from the platform. No impact marks or inward deformation of the fan exit fairing were noted.

The nine sound absorbing inner rear liner segments were removed from the engine and debris was removed from the inboard side of each screen and individually bagged. The bleed valve assembly was found in the open position (this should be the default position on engine shutdown). A large amount of debris (soil, vegetations, rocks, etc) was found at the 6:00 o'clock position of the fan case as well as in the bottom of the bleed valve linkage support. Centered around the 9:00 o'clock position (aft looking forward), a concentration of the organic material was stuck to the outside of the bleed linkage support, with the rest of the support exhibiting very little.

Organic debris was gathered from all nine sound absorbing inner rear liner segments, from each stage of the LPC stages, from fan blades 8, 9, 10, 19 and 20 and from bleed valve linkage support.

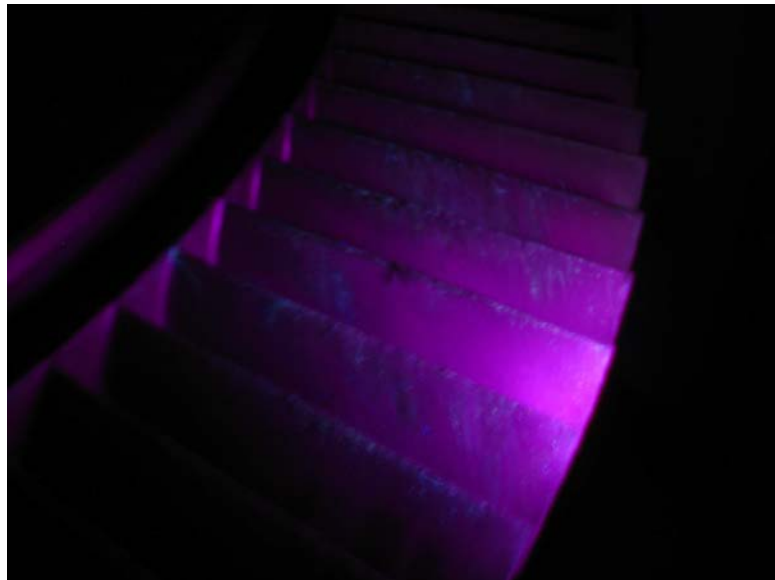
Black Light Inspection of Engine Nr3

The fan blades were inspected using a black light with the blades still installed in the fan disk. A **heavy and concentrated** organic smear and splatter in the axial direction on the concave side of the fan airfoils was observed at the platform between blades Nos. 31 & 32 and 32 & 33 (convex side) (242° from index mark). Blades No. 42 and 43 (329° from index mark) exhibited a light and more spread out organic smear and splatter on the airfoil concave with the smear flowing towards the blade tips. The blade numbering used are the blade numbers used during the initial installation and they sequentially increase clockwise forward looking aft.

Organic speckled material with no directional orientation was noted on the fan exit fairing around the 6:00 o'clock position. A black light inspection of the stage 1.5 low pressure blades revealed an organic smear of 6 consecutive blades on the concave side (pressure).

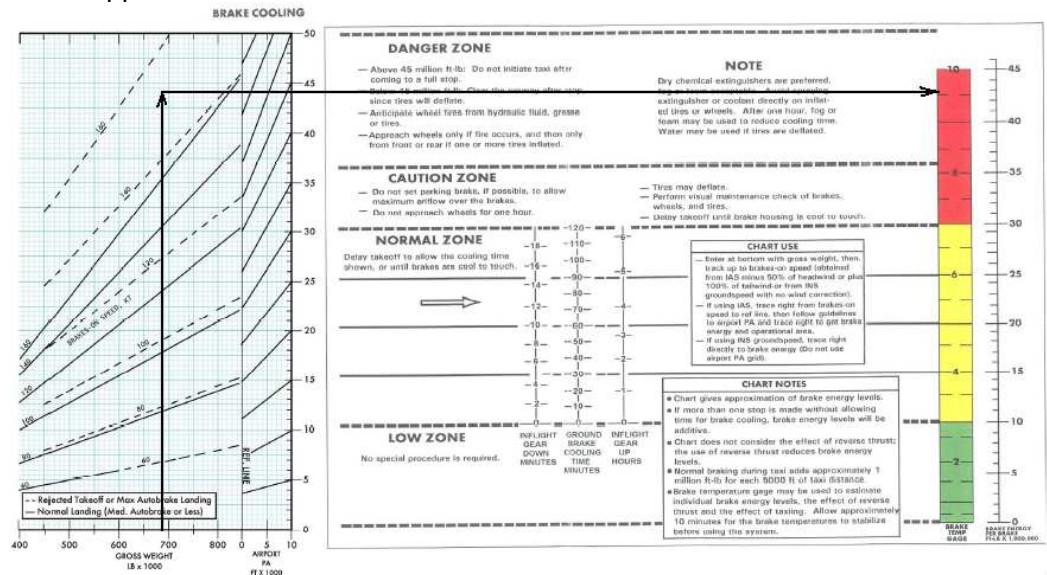
The Boeing B747 brake energy chart for aborted takeoff or maximum braking shows an accumulated energy of 44.10^6 ft-lbs (maximum speed 152kts). The maximum available brake energy level is 45.10^6 ft-lbs. This level is in the danger zone of the brake energy chart, where tires are likely to deflate and wheel fires must be anticipated.

On the wreckage, 14 out of 16 tires were found intact after the aircraft was stopped.

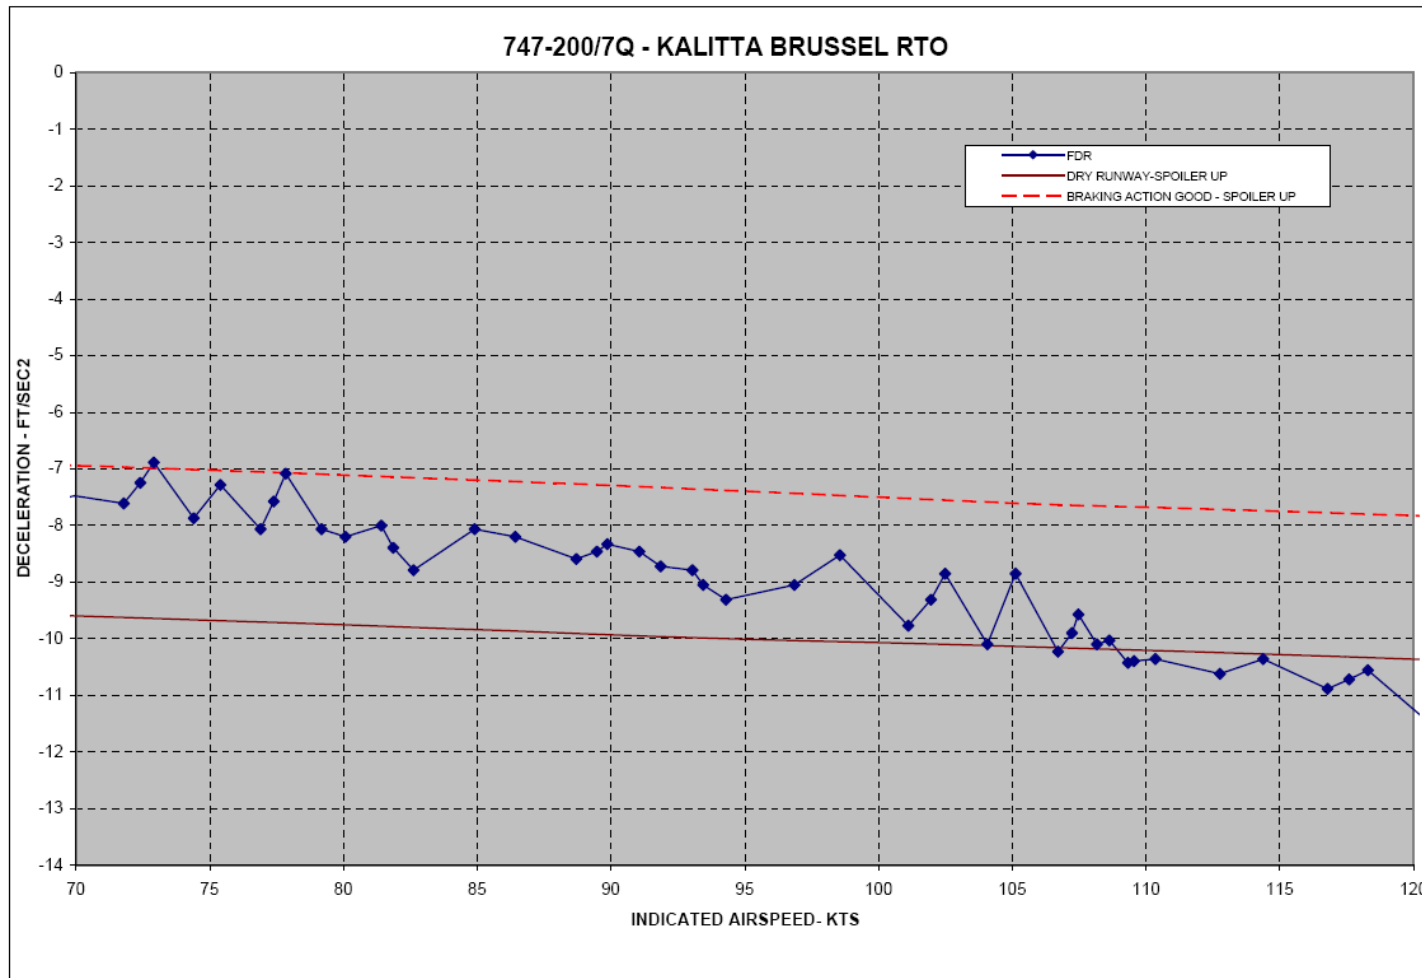
The FDR deceleration with airspeed is greater than calculated. The estimated deceleration is based on a constant airplane braking coefficient, which for spoilers extended are 0.2810 and 0.20 for dry and wet runway respectively. The greater rate of change of the FDR deceleration at lower airspeed when compared to the calculated rate of change may be explained by variable runway friction, i.e. the runway texture may contain more moisture or a combination of runway rubber deposit and moisture closer to the end of the runway.

Figure 1: FDR deceleration in ft/sec² as a function of indicated airspeed along with the estimated deceleration as a function of airspeed with spoilers extended for both dry and wet runway.

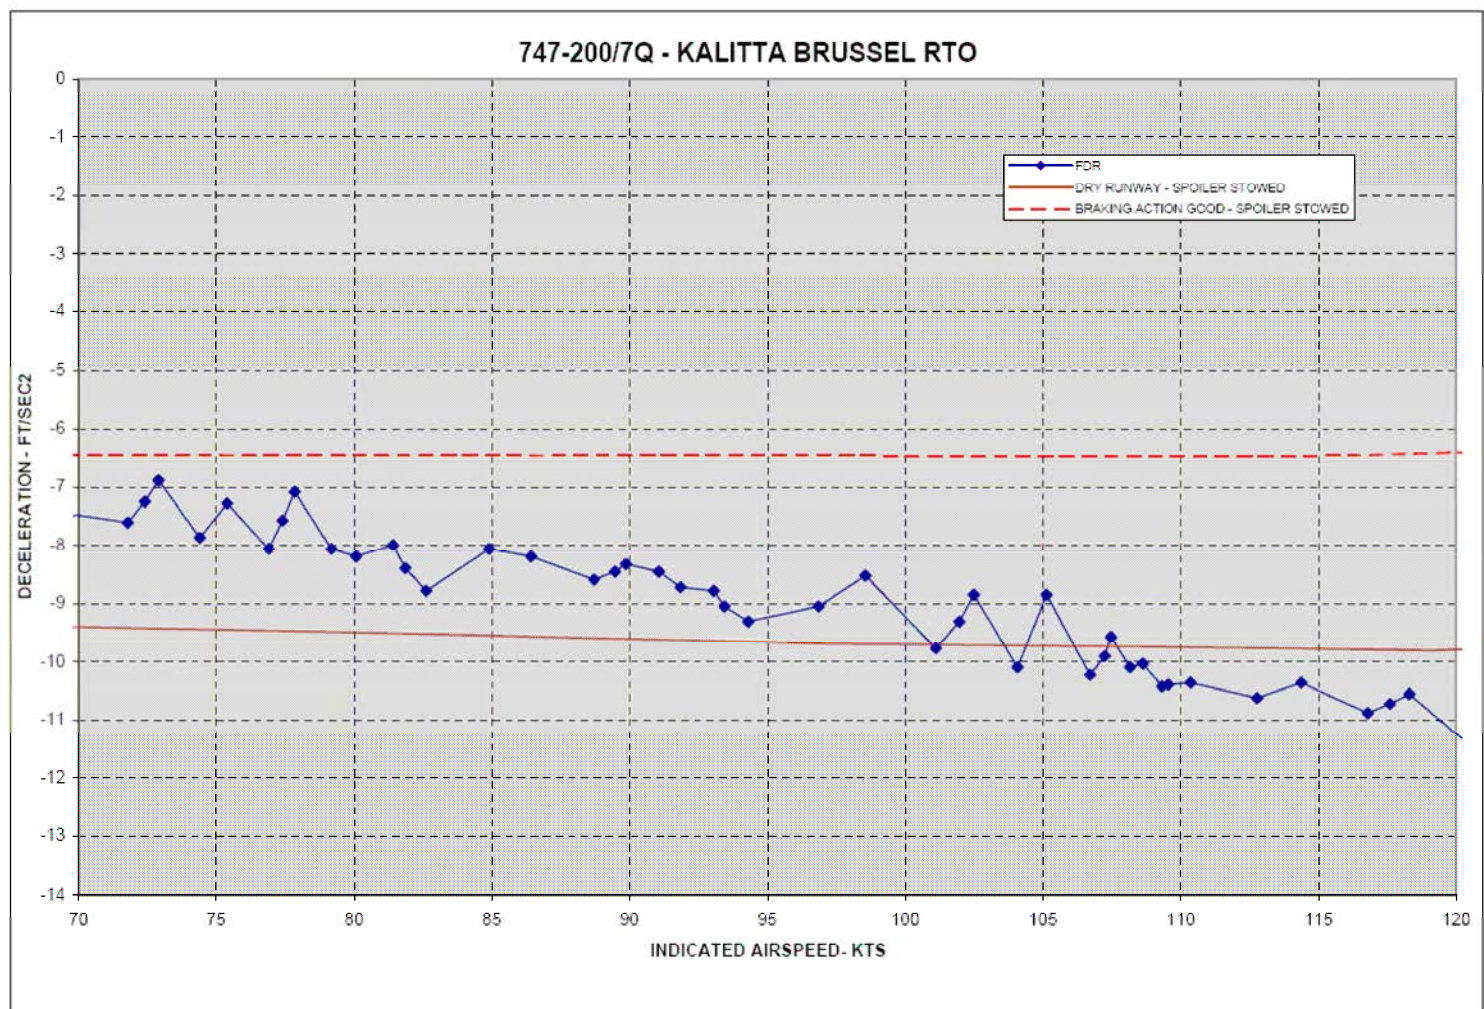
Figure 2: FDR deceleration in ft/sec² as a function of indicated airspeed along with the estimated deceleration as a function of airspeed with spoilers stowed for both dry and wet runway.
