**FINAL REPORT ON THE ACCIDENT OCCURRED
ON 25 MAY 2008
AT BRUSSELS AIRPORT ON A BOEING
B747-209F REGISTERED N704CK**

**Ref. AAIU-2008-13
Issue date: 10 July 2009
Status: Final**

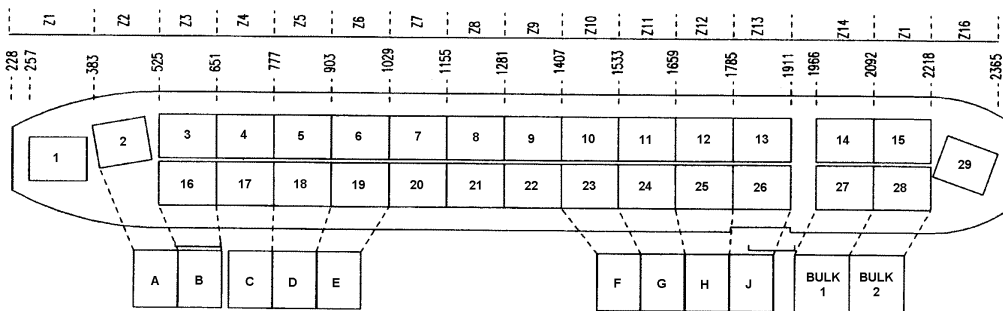
The loading was retrieved from the wreckage, and weighed at the facility of Flight Care in Brussels Airport. No significant deviation were observed with respect to the Load Sheet.

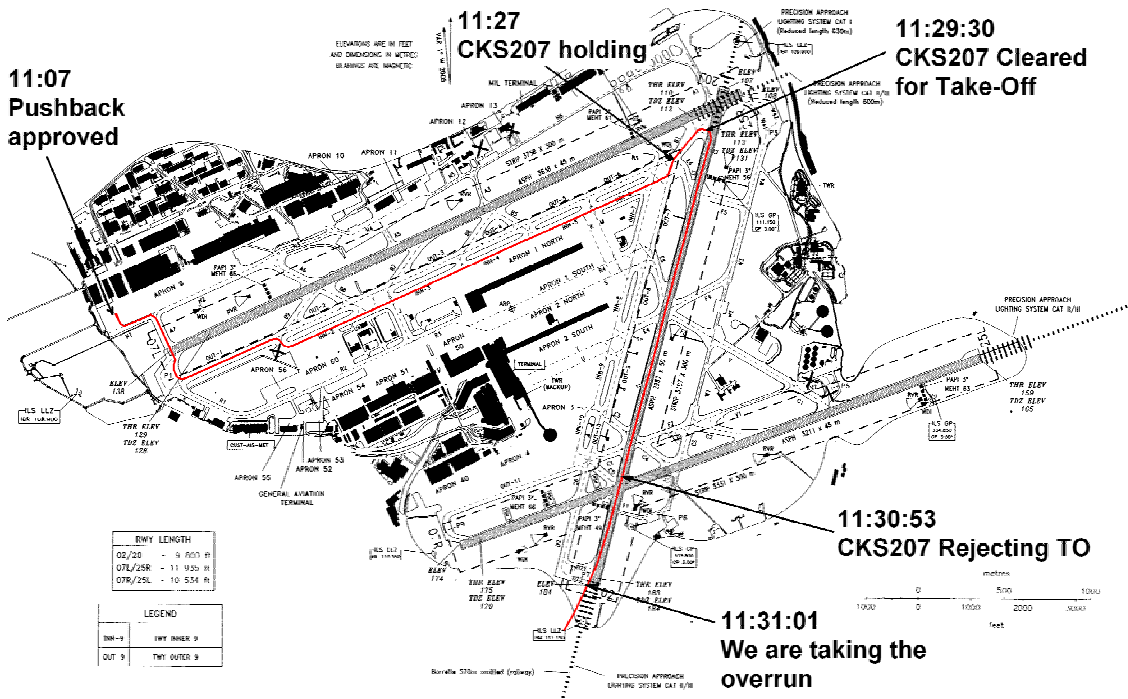
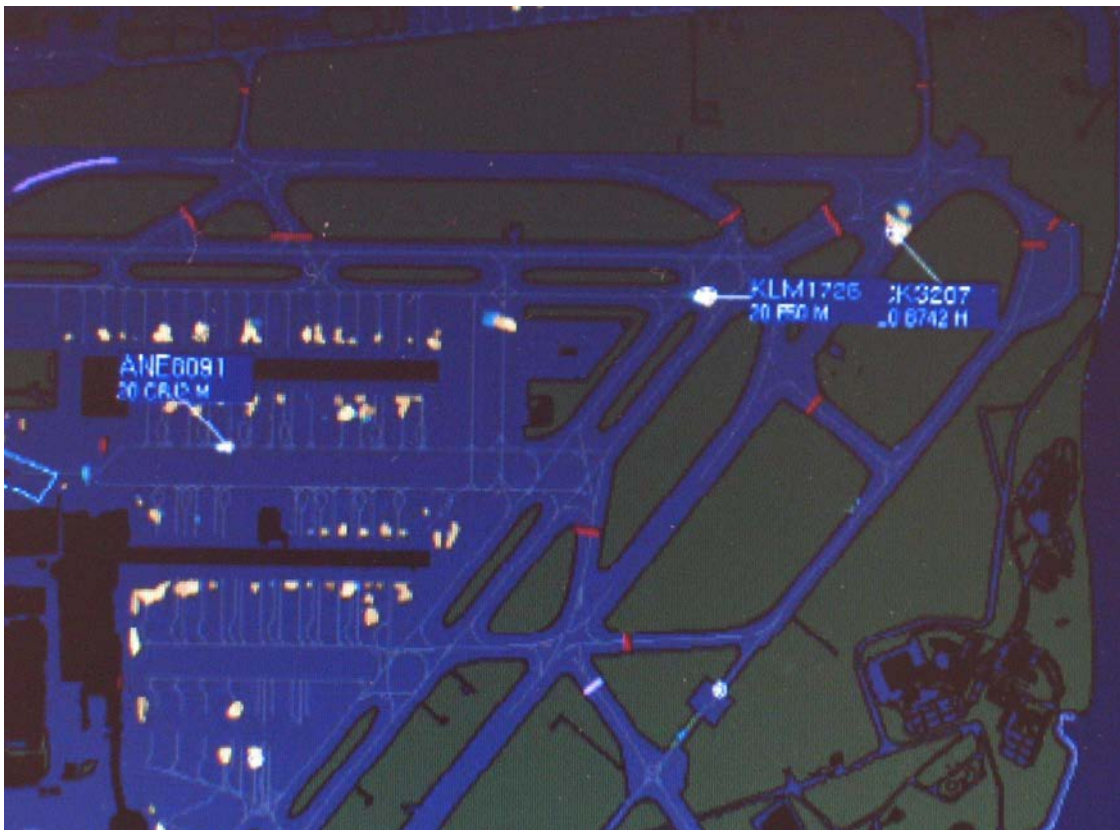
Ground radar image of CKS207 lining up on R20.

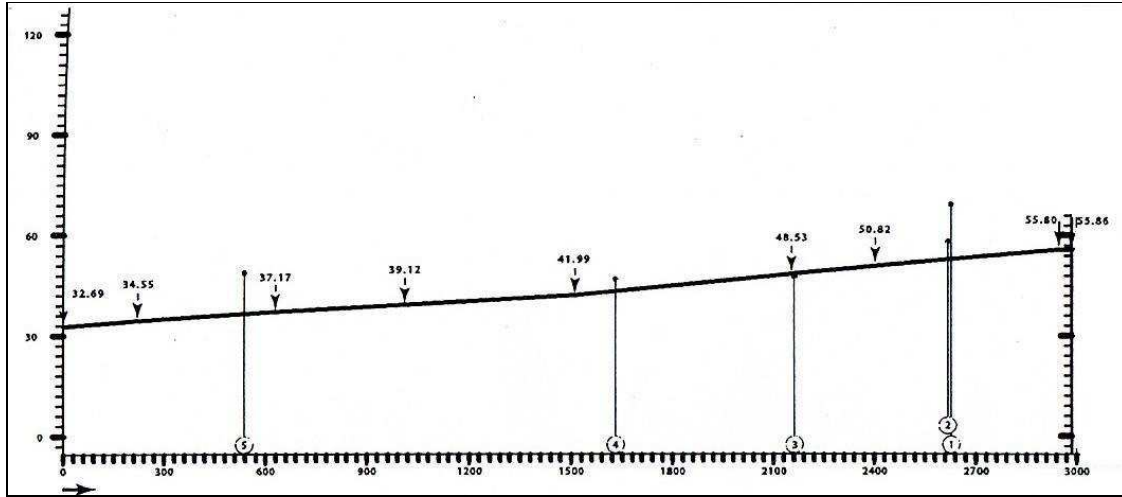
Runway 20 - slope

The slope on runway 20 is on average +0.78%; but from 0 to 1500m, the runway has a slope of 0.62, then for the remaining 1487m, it has an increased slope of 0.93%. Both values are complying with the ICAO recommended limits.

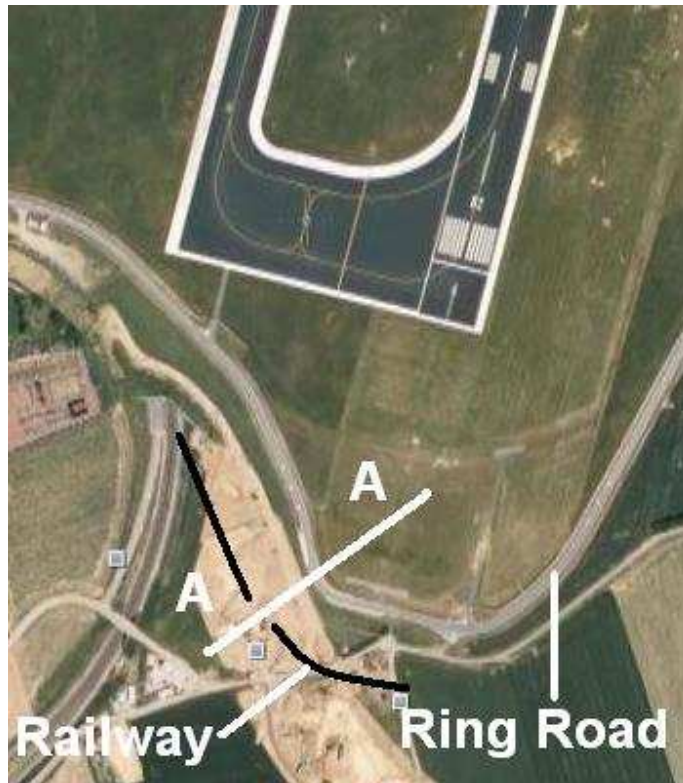
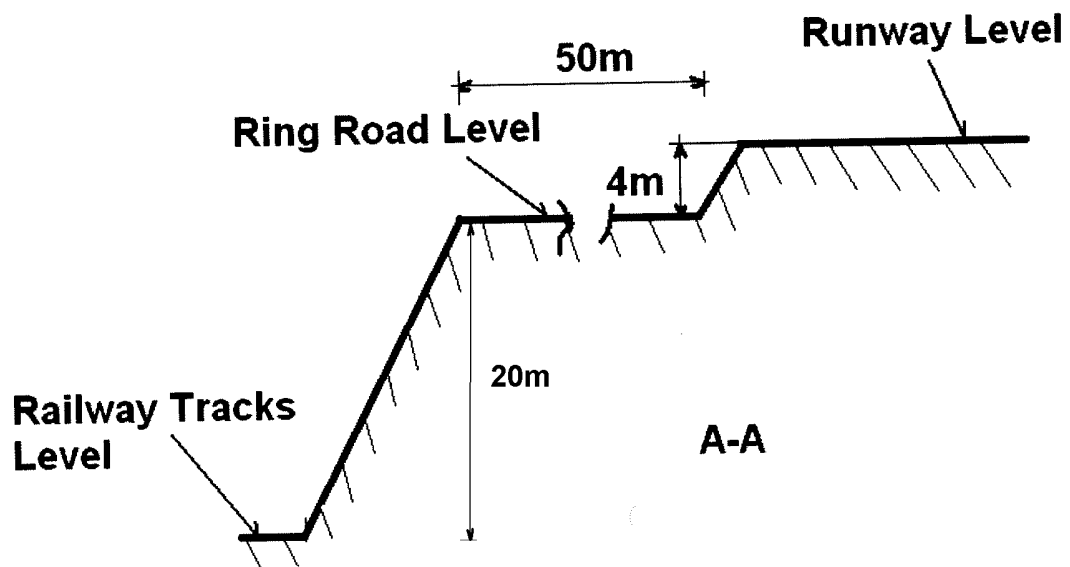
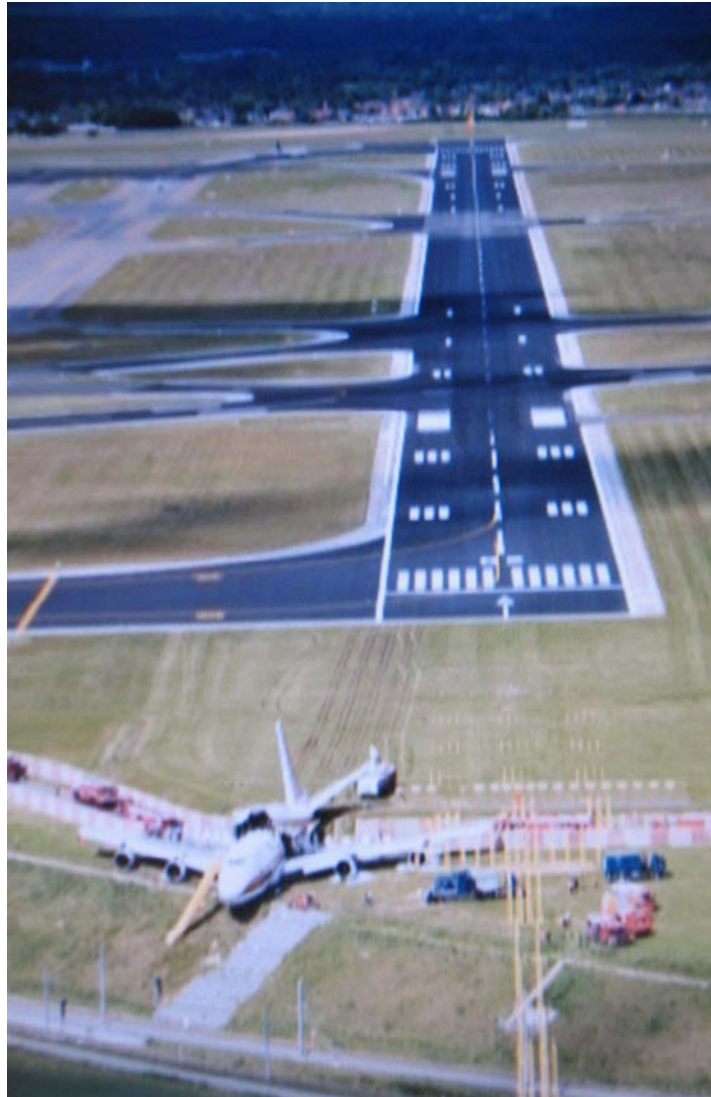
However, the same ICAO Annex 14 recommends to extend the length of the RESA to a distance of at least 240m. This recommendation (not mandatory) is not met for runway 20.

The runway is bordered by a road located 4m lower than the runway. The railroad tracks of the line Brussels – Leuven is 50 m further back, 20m lower than the ring road level.

The extension of the RESA seems difficult due to the presence of the railroad tracks, in the direction of R20 and roads in the opposite direction. The extension would involve serious costs.

A possibility to increase the efficiency of the RESA is to install an **Engineered Material Arrestor System (EMAS)** in order to create an additional braking effect.

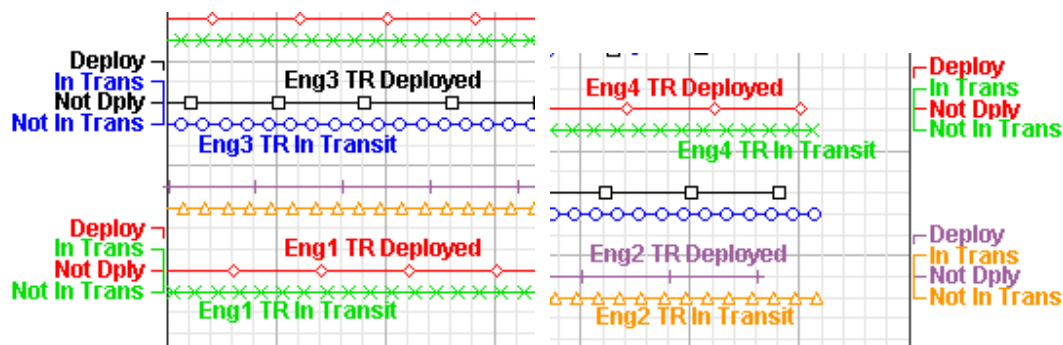
The FDR data show the airplane taxiing onto runway 20 in Figure 1 at time 54235 seconds. Seven seconds later the engine pressure ratio begins increasing to takeoff thrust. At time 54286.5 seconds the aircraft reaches V1 (V1 = 138 knots). Four seconds later the right inboard engine shows a 0.1 EPR reduction. Within one second of the EPR reduction, longitudinal acceleration decreases and at time 54292.5 seconds EPR decreases for the remaining three engines. The decrease in longitudinal acceleration is the first indication of a Refused Take Off (RTO) in the data and occurs at an airspeed of 150 knots (V1 + 12 knots). At time 54294 seconds deceleration levels off at -0.28 g's for just over one second before increasing to the maximum deceleration recorded during the RTO of -0.38 g's. At the time of the maximum longitudinal deceleration a spike in lateral acceleration occurs to the right, see figure 2. The lateral movement changes the heading of the aircraft, allowing it to exit the runway off to the right side in order to avoid obstacles. Since there were no significant rudder movements at this point and the nose gear tires showed no sign of being turned, the lateral acceleration spike (and resultant heading change) was most likely the result of differential braking.

The airplane departed the runway at time 54307 seconds with airspeed of 72 knots. The increase in normal load factor variability correlates to the ground track distance data. the end of useable data most likely marks the final impact of the airplane on the lower edge of the embankment.

Among others, the data analysis revealed that the thrust reversers were not deployed.

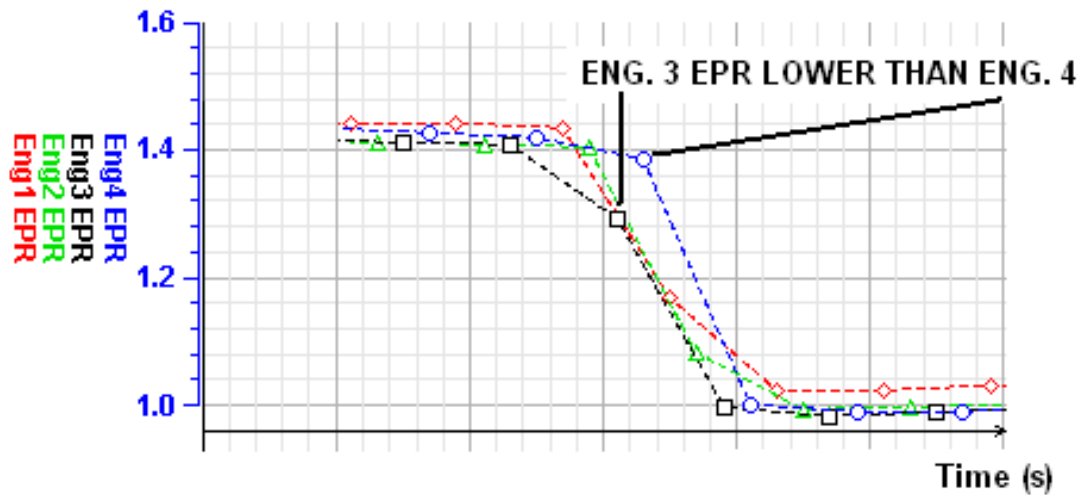
The FDR gives the evolution of Engine Pressure Ratio (EPR) – delivered engine thrust – per unit of time.

As outlined hereabove, the EPR parameter is taken once every 4 seconds for a given engine, and sequentially each second for each different engine. In the graph hereabove, the sequence is engine Nr2 (green triangle) then Nr3 (black block), then Nr4 (blue circle), and finally Nr1 (red losange).

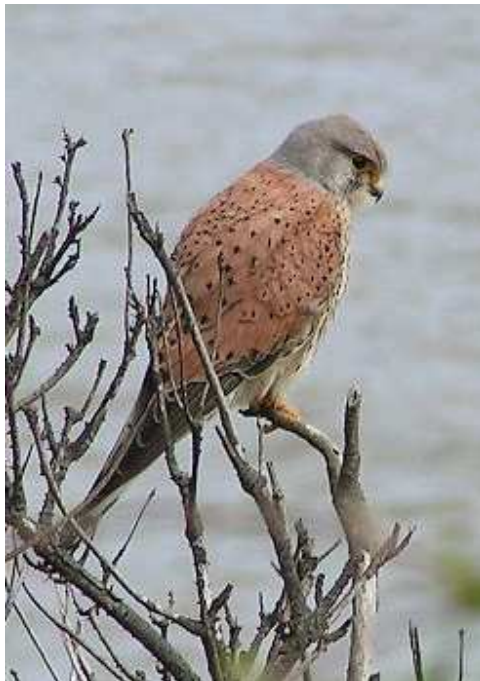
The Smithsonian Institute Museum of Natural History – Bird Division performed an inspection on the remains, as well as DNA analysis.

The results were consistent with the characteristics of the European Kestrel (*Falco Tinnunculus*).
